National Dam Inspection Program.

~~FEDERAL~~ SHEPPARD Dam

(NDI ~~NO~~ ^{Number} PA-00333,

PHASE I INSPECTION REPORT,
NATIONAL DAM INSPECTION PROGRAM

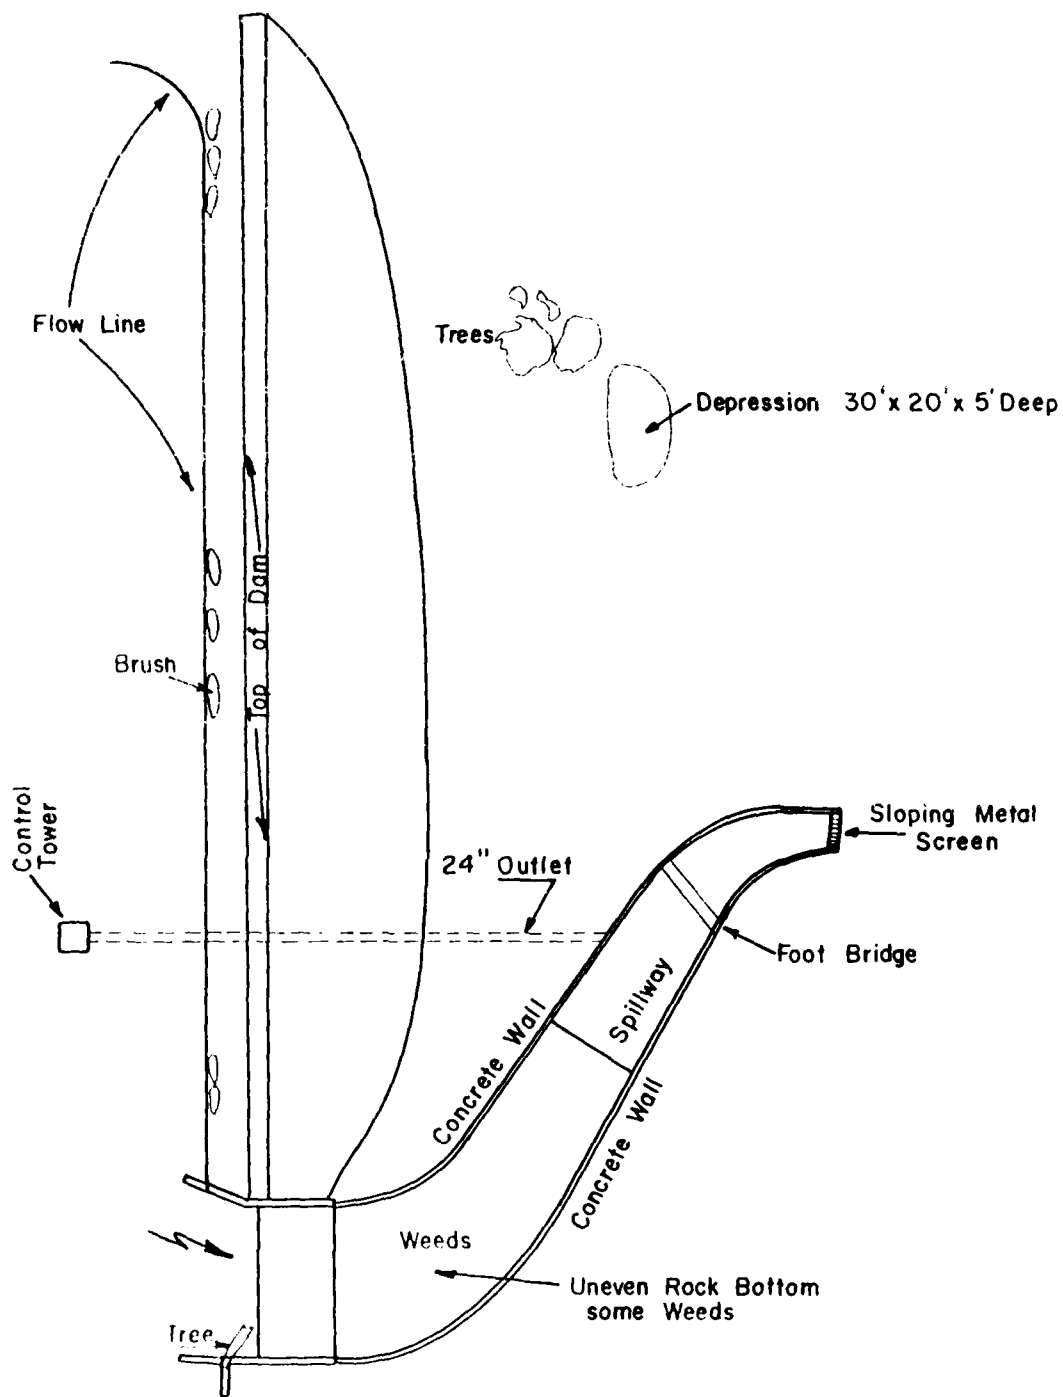
SHEPPARD DAM
PA - 00333
INSPECTION SURVEY
PLATE A-I

One large 5'± deep x 30' x 20' depression is located about 60-70 feet beyond the toe of the downstream slope. Its origin is unknown. It was moist on the bottom.

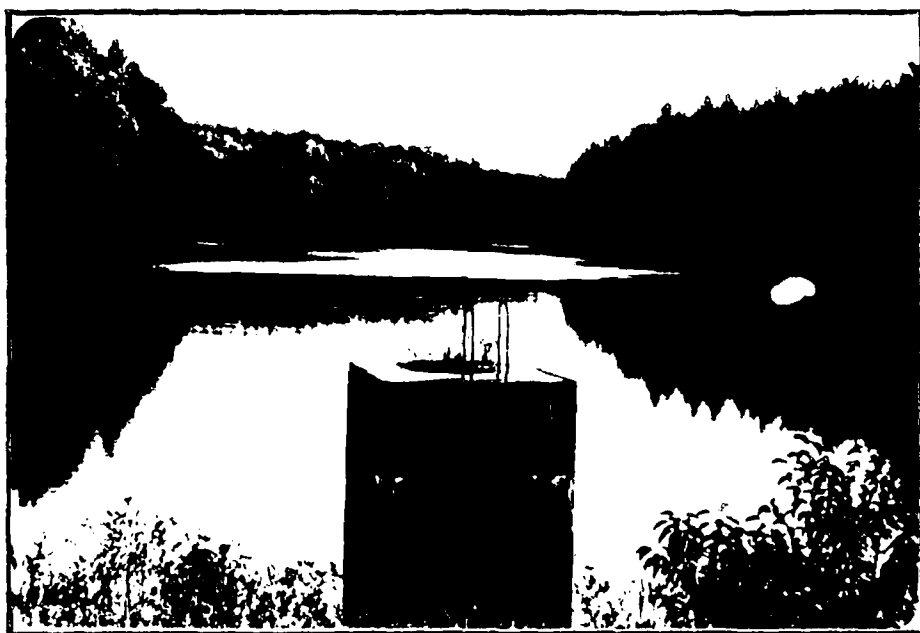
The control tower (Photograph No. 8) is located near the upstream toe and is accessible only by boat. The gate control in this structure, to operate the blow off, has not been used in at least 20 years. The blow-off pipe outlets into the spillway discharge channel. This is a variation from the design drawings.

The only operating facility is the sliding gate in the control tower which is used to control the discharge through the blow off pipe. This gate has not been maintained or operated over at least 20 years.

RESERVOIR AREA AND INTAKE STRUCTURE - NO. 8

The operational procedures for Sheppard Dam are minimal at the present time. Although the dam is in good condition, operational procedures should include the clearing of brush in the spillway and upstream slope at regular intervals. The sliding gate in the control tower should be maintained and operated periodically. A formal surveillance and downstream warning system should be developed for implementation during periods of high or prolonged rainfall.
